# Field Study Photographs for Historic Preservation

Volume 2  
Chemical Cleaners for Architectural Materials,  
Spring, 2003

CHEMICAL CLEANERS

Architectural Conservation (IAR 548) Laboratory Experiments

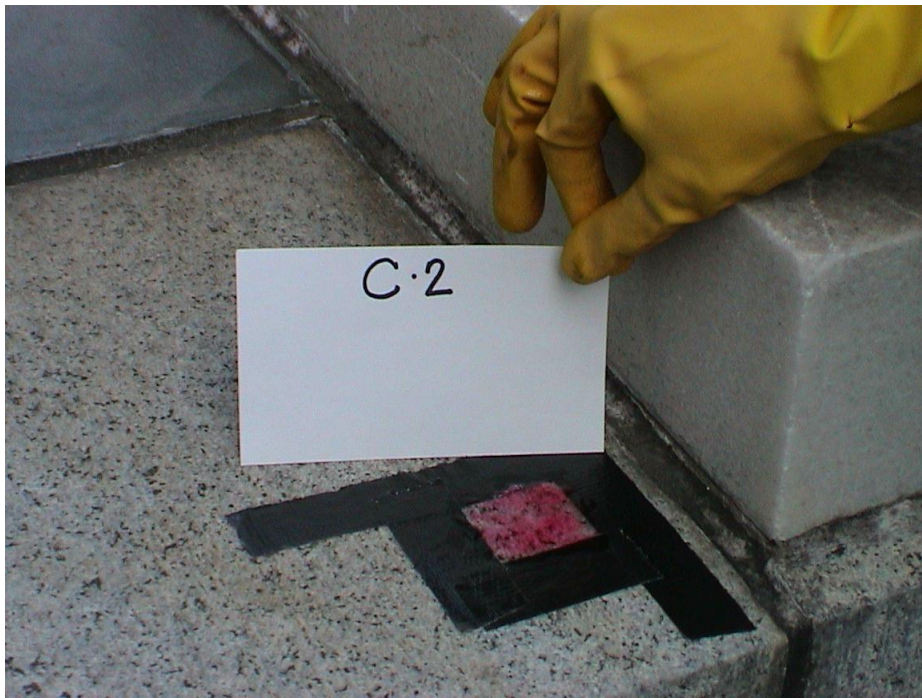
Figure 38. The orthophosphoric acid poultice is left for a few minutes to act on the granite surface.

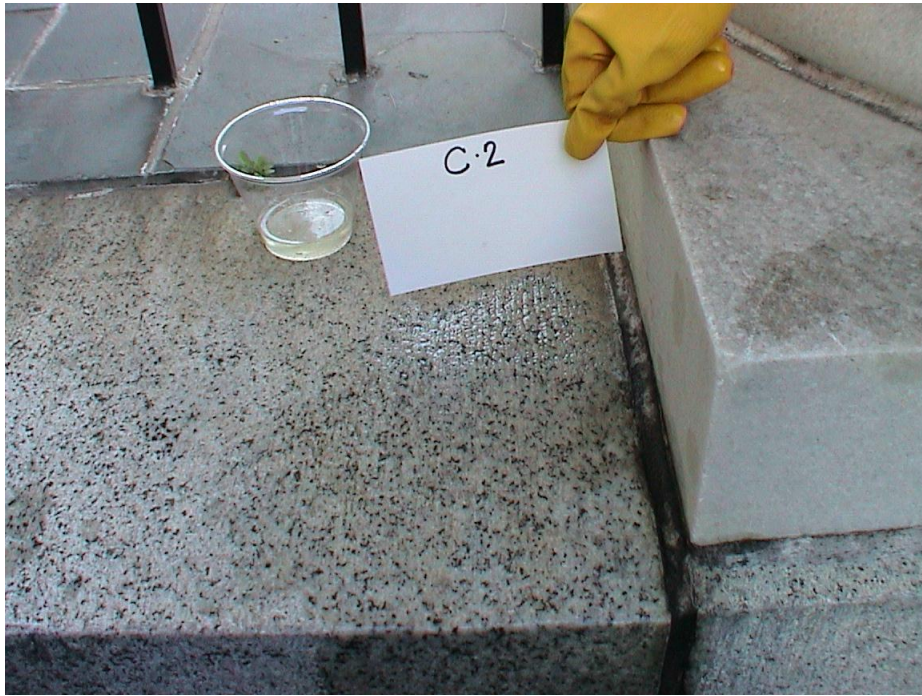
Figure 39. Remove the tape after the orthophosphoric acid is thoroughly rinsed off with water.

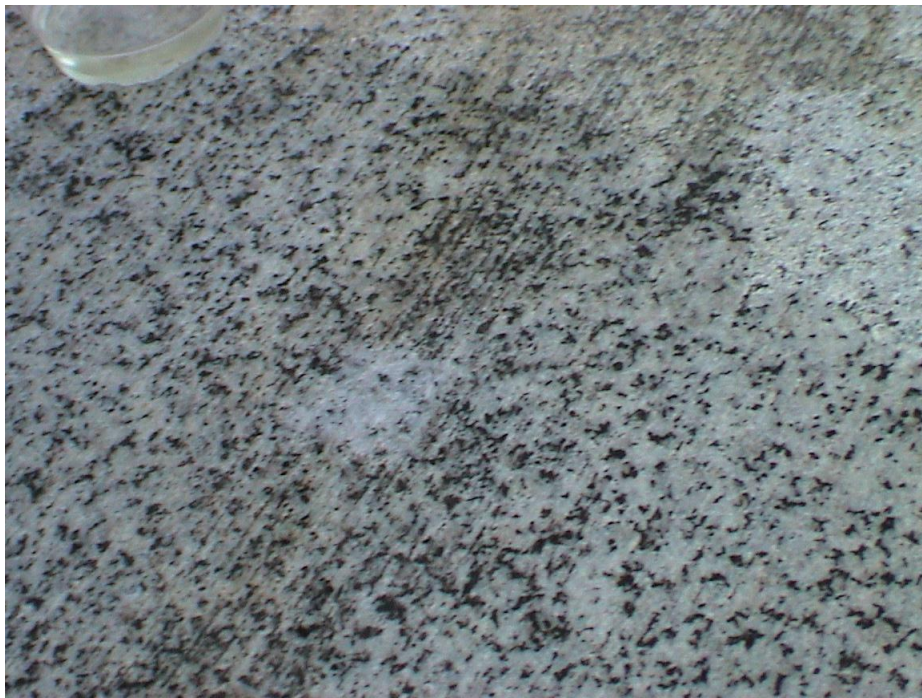
Figure 40. This is test area C-2 after the water has dried.

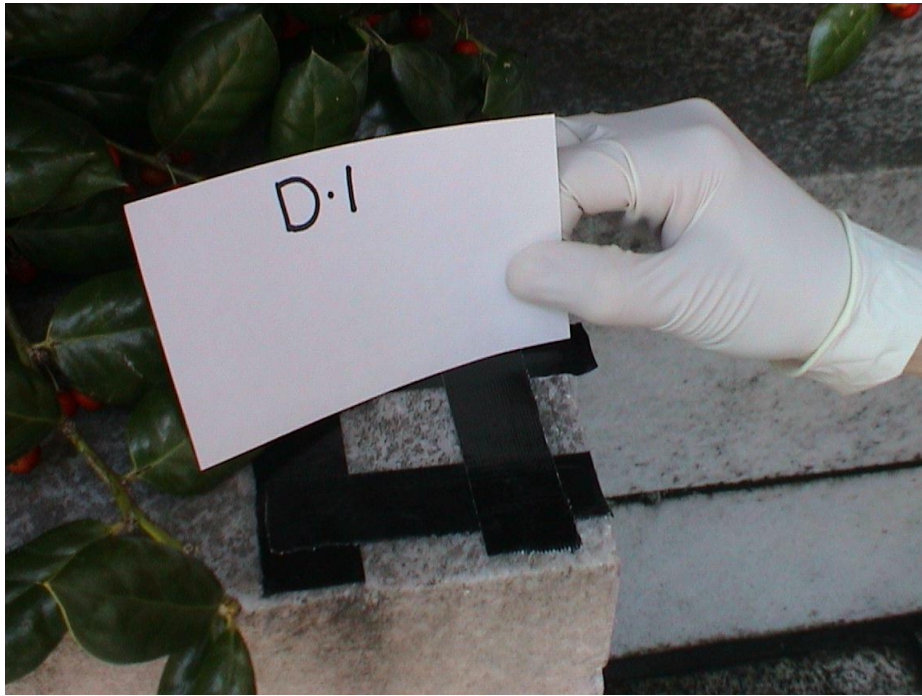
Figure 41. Test area D-1 is on a marble surface.

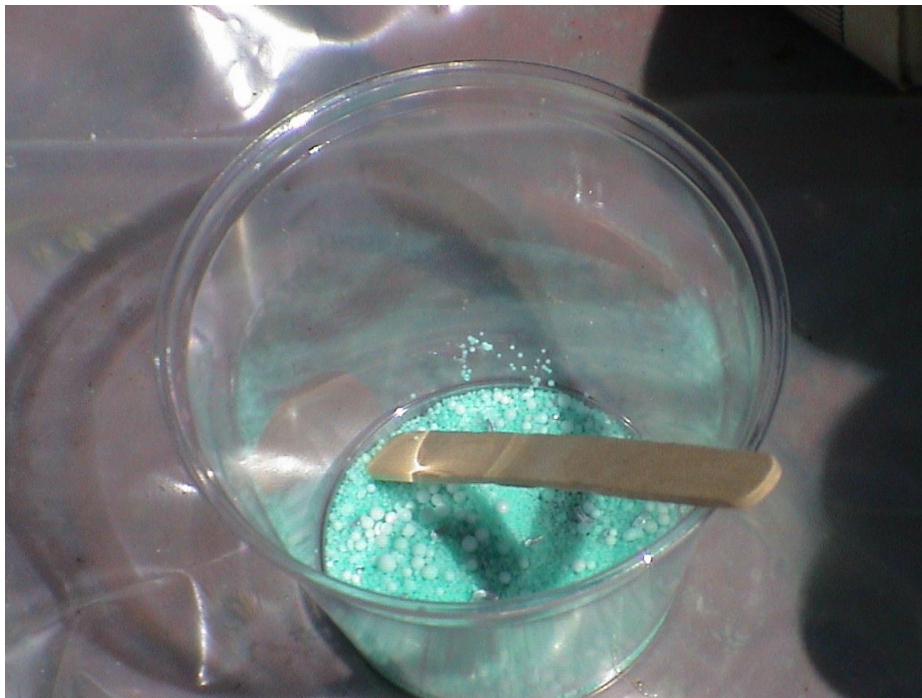
Figure 42. A solution of sodium hydroxide (lye) and water is prepared for use on test area D-1.

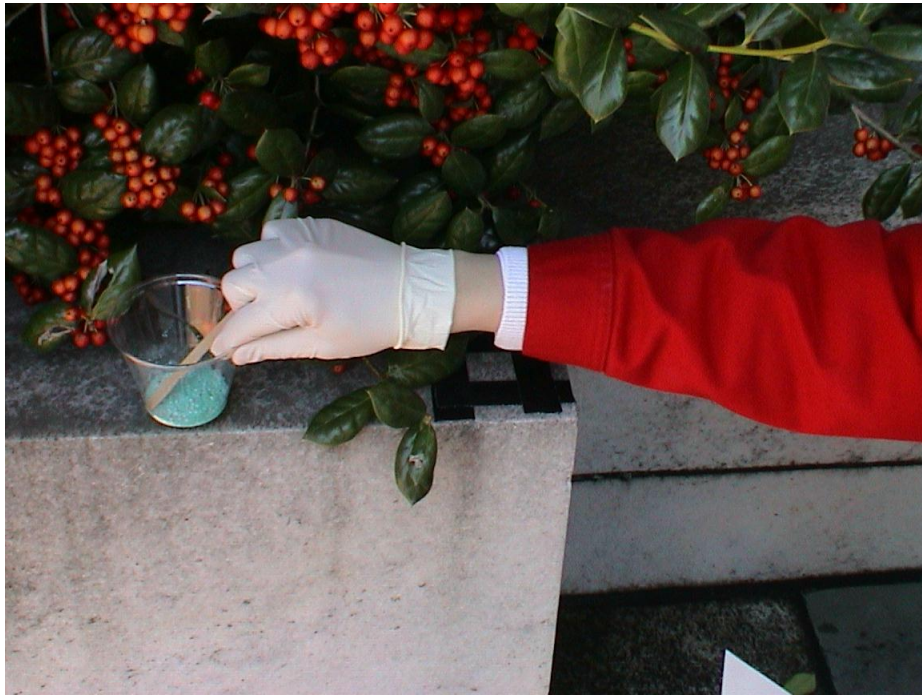
Figure 43. The sodium hydroxide solution will remove fungal stains on the marble that Results from having the holly bush shading the stone's surface.

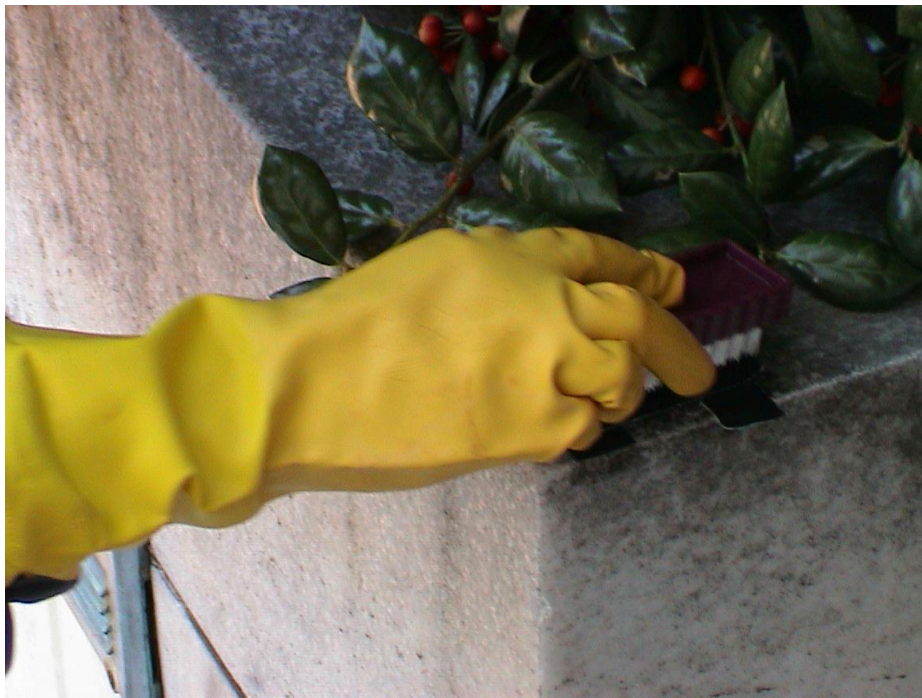
Figure 44. The sodium hydroxide solution is brushed onto the surface of test area D-1.

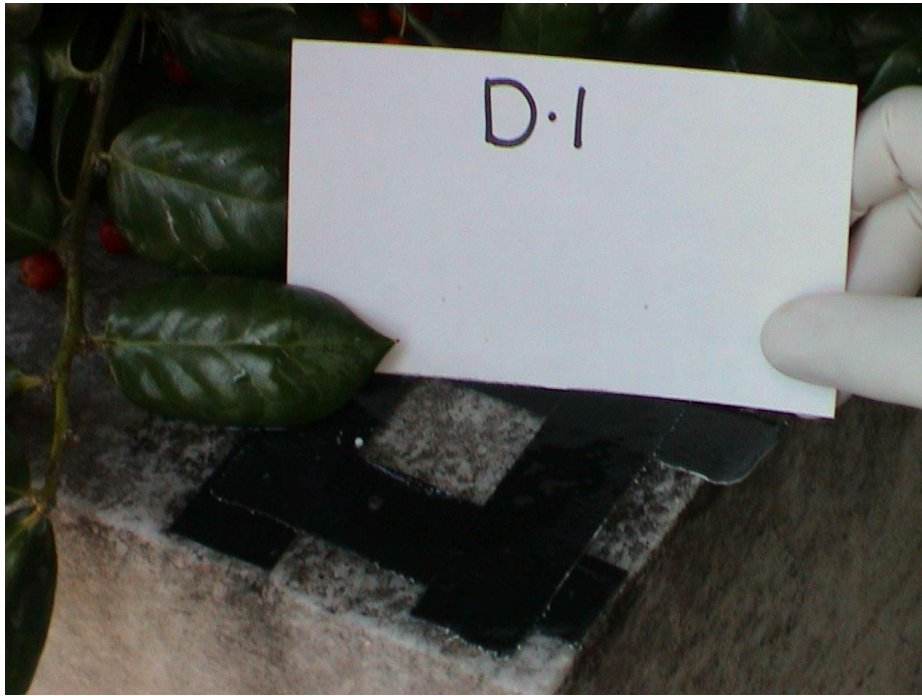
Figure 45. The sodium hydroxide solution is left to act upon the fungal stain on test area D-1.

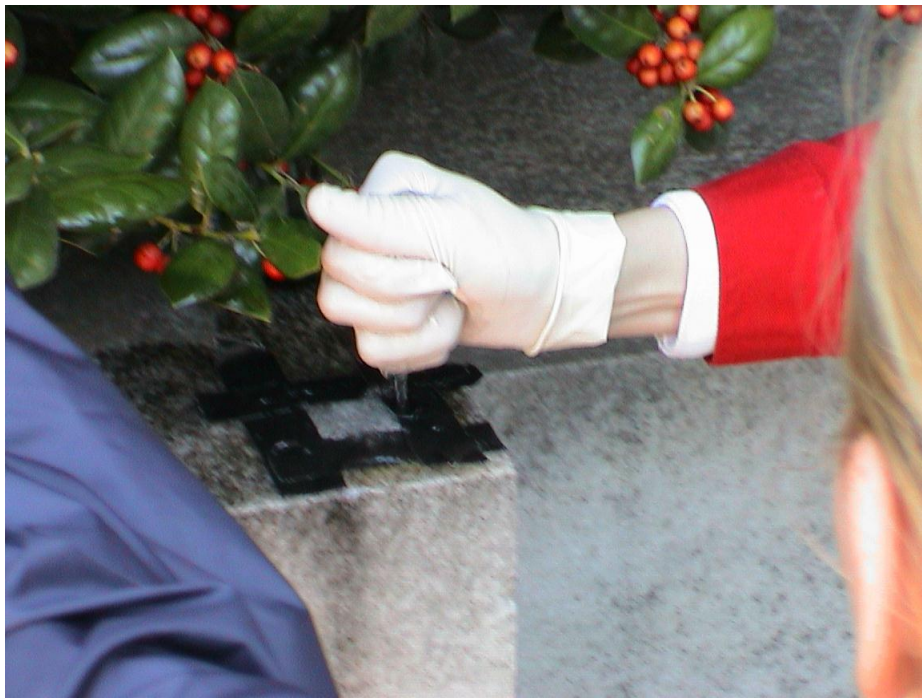
Figure 46. The sodium hydroxide solution is removed with water.

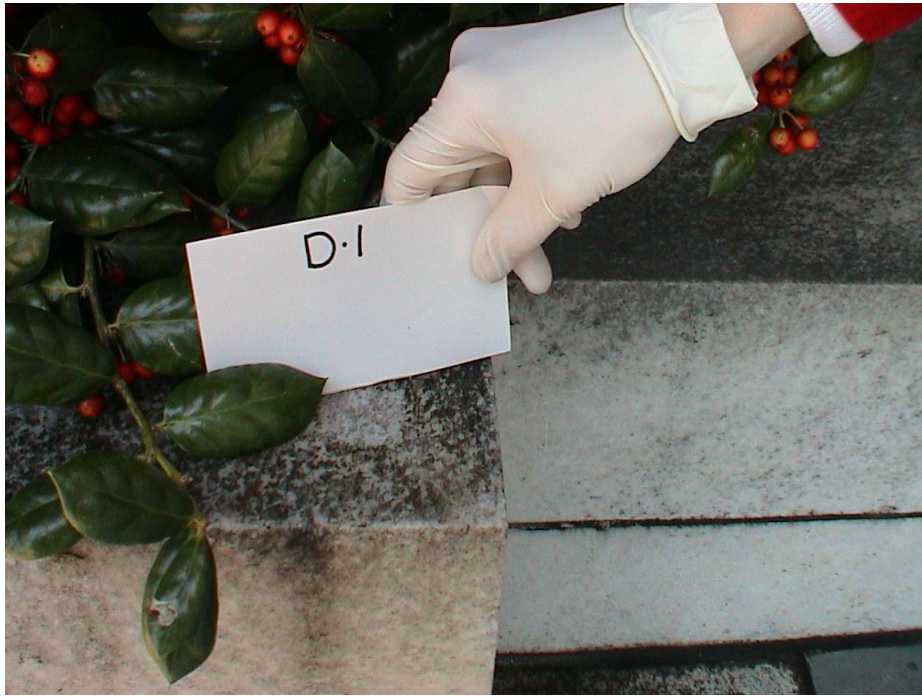
Figure 47. The fungal stain on the surface of test area D-1 was removed by the sodium hydroxide solution.

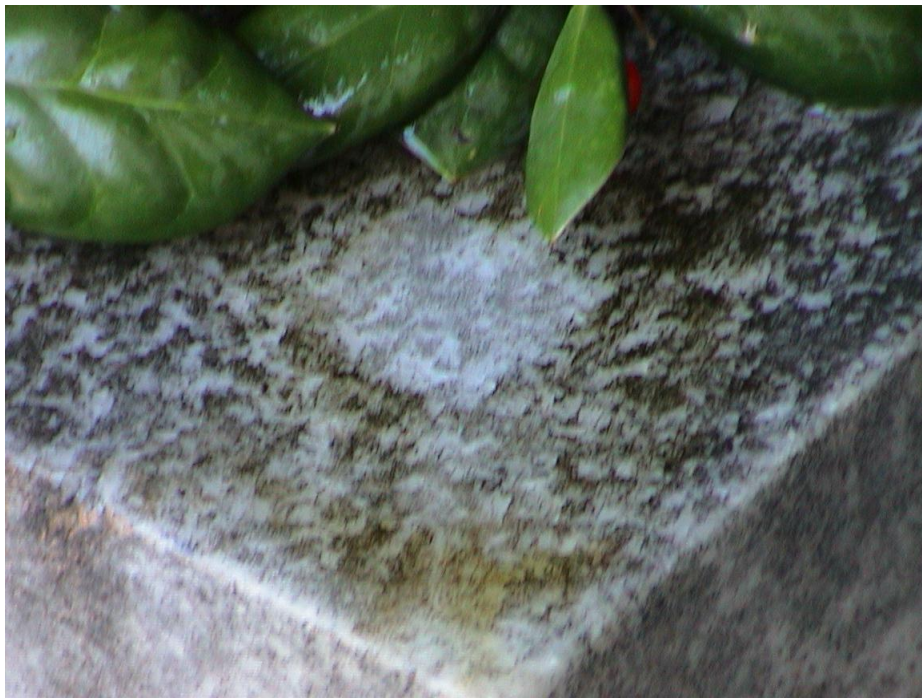
Figure 48. This is a close-up of test area D-1 after treatment with sodium hydroxide Solution.

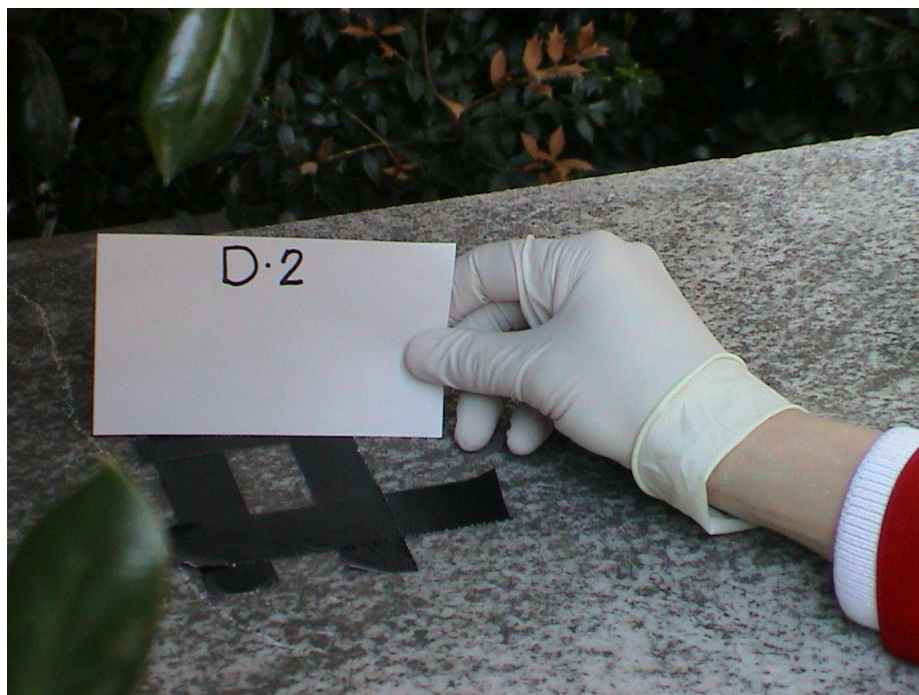
Figure 49. Another test area D-2 is set up on the marble surface near D-1.

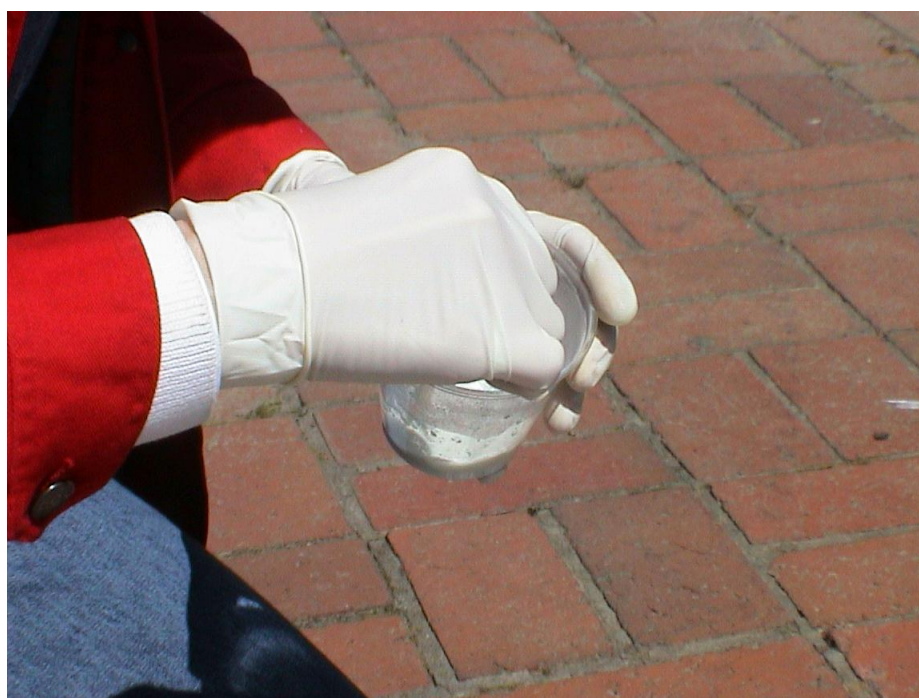
Figure 50. A poultice can be prepared from diluted ammonia or hydrogen peroxide for use on marble surfaces. One team in the class is considering making their poultice with ammonia. This researcher, however, prepares a poultice of hydrogen peroxide and talc.

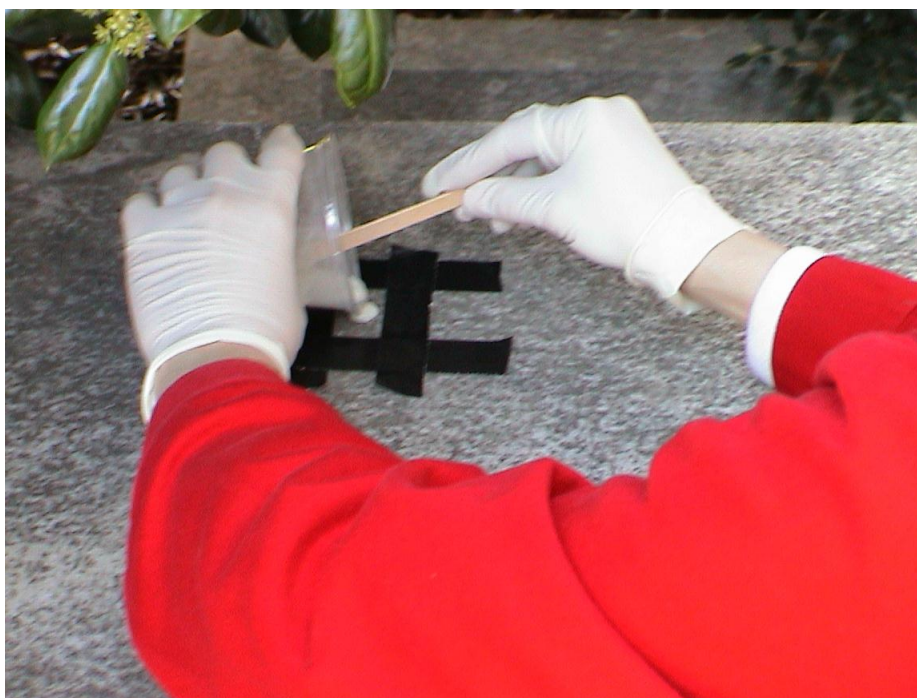
Figure 51. The hydrogen peroxide and talc poultice is applied to test area D-2.

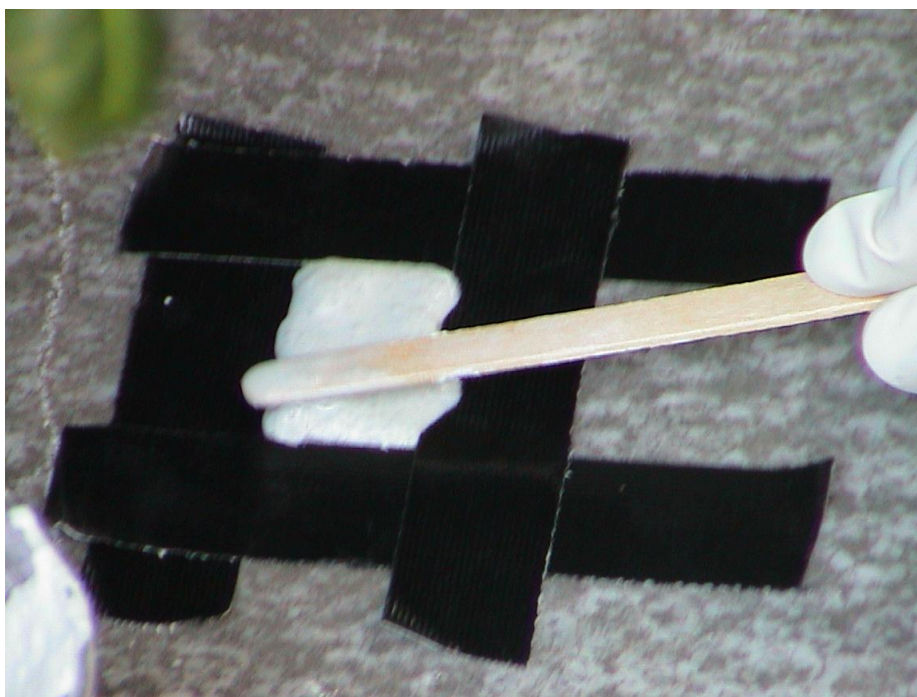
Figure 52. A wooden applicator is used to spread the hydrogen peroxide and talc poultice evenly on test area D-2.

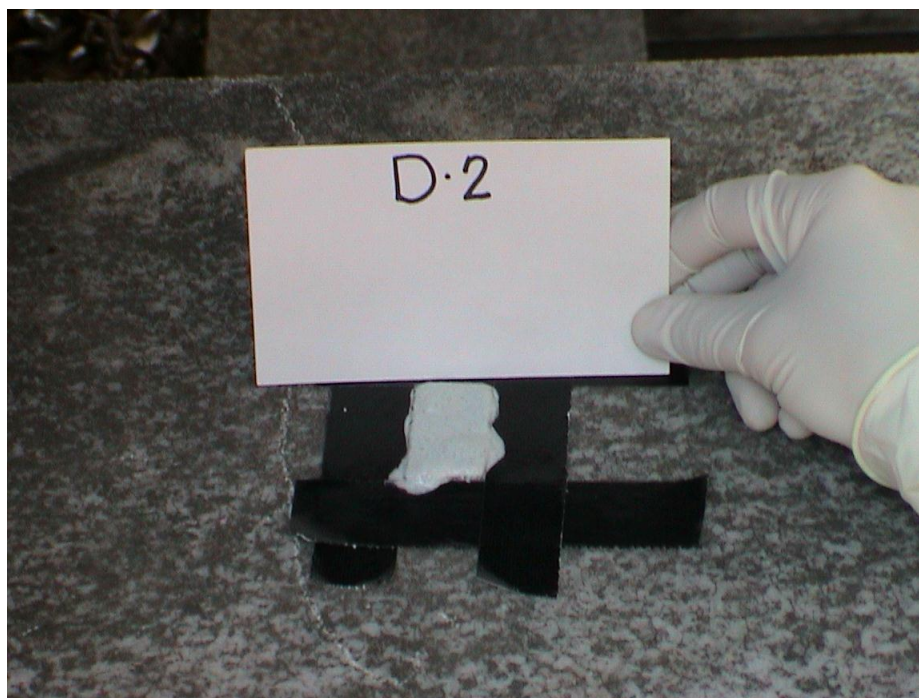
Figure 53. The hydrogen peroxide and talc poultice is left to act upon the marble surface.

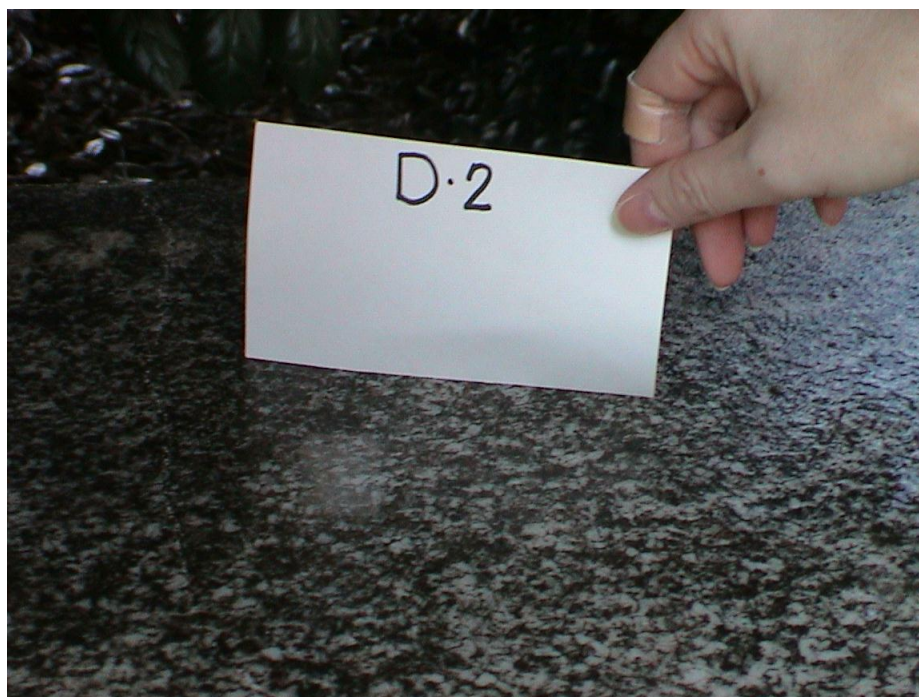
Figure 54. The hydrogen peroxide and talc poultice is washed off the marble surface after 20 minutes.

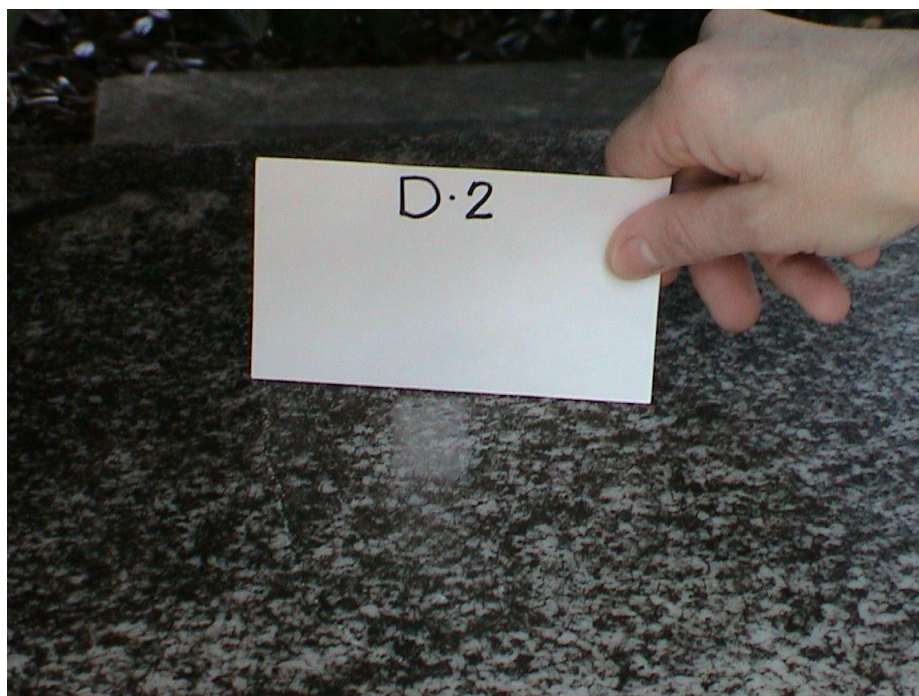
Figure 55. This is a photograph of a test area D-2 after being allowed to dry.
